## Convict Trail Project

## January 2023 Newsletter

### **A VIRTUAL WALK UP THE GNR: The Conservation of Clares Bridge**

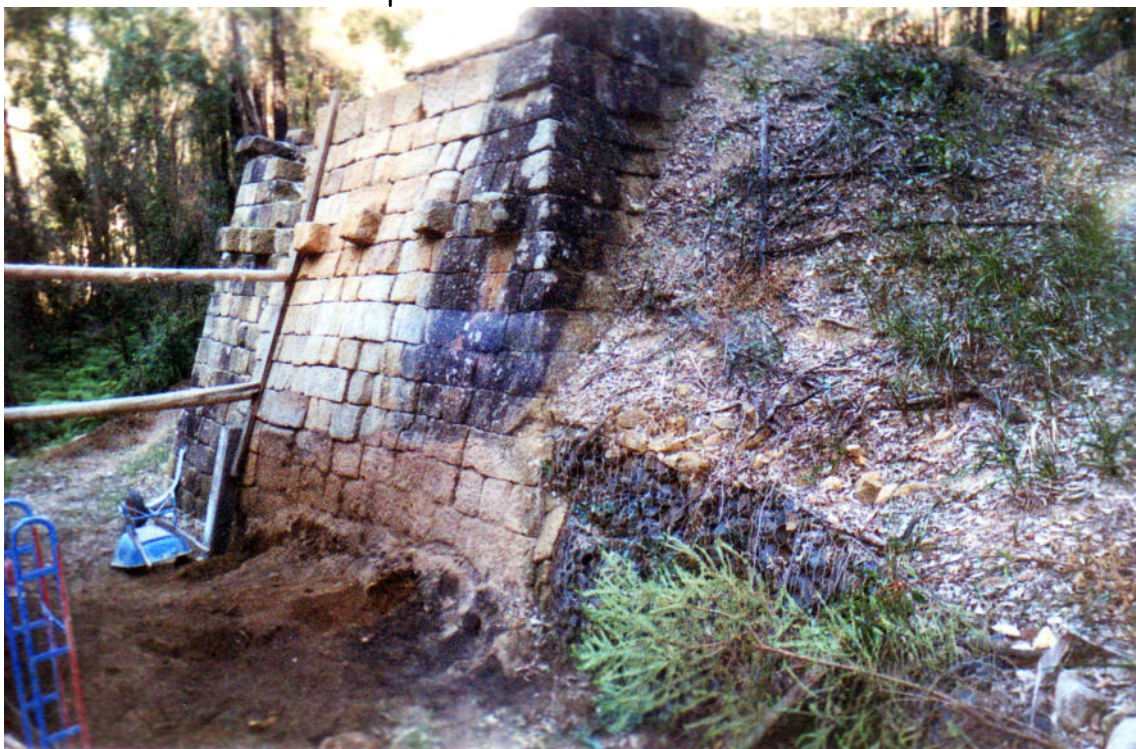
*[Southern abutment with decking removed]*

This revealed one of the stones near the base of the southern abutment near the area that was restored was badly crushed, tipped and had failed. The remaining fill was left in place and the abutment was propped against the central pier.

The CTP applied for, and got, a grant to conserve the stone work. Having got the grant, it became apparent that a whole lot of other work would have to occur to enable the stone abutment to be conserved. The 1960s decking had to be removed. The large concrete block that held up the 1960s decking also had to be removed. This block had been poured onto unconsolidated original filling with no piers to the bed rock, and it was exerting downward and outward pressure and causing the problems.

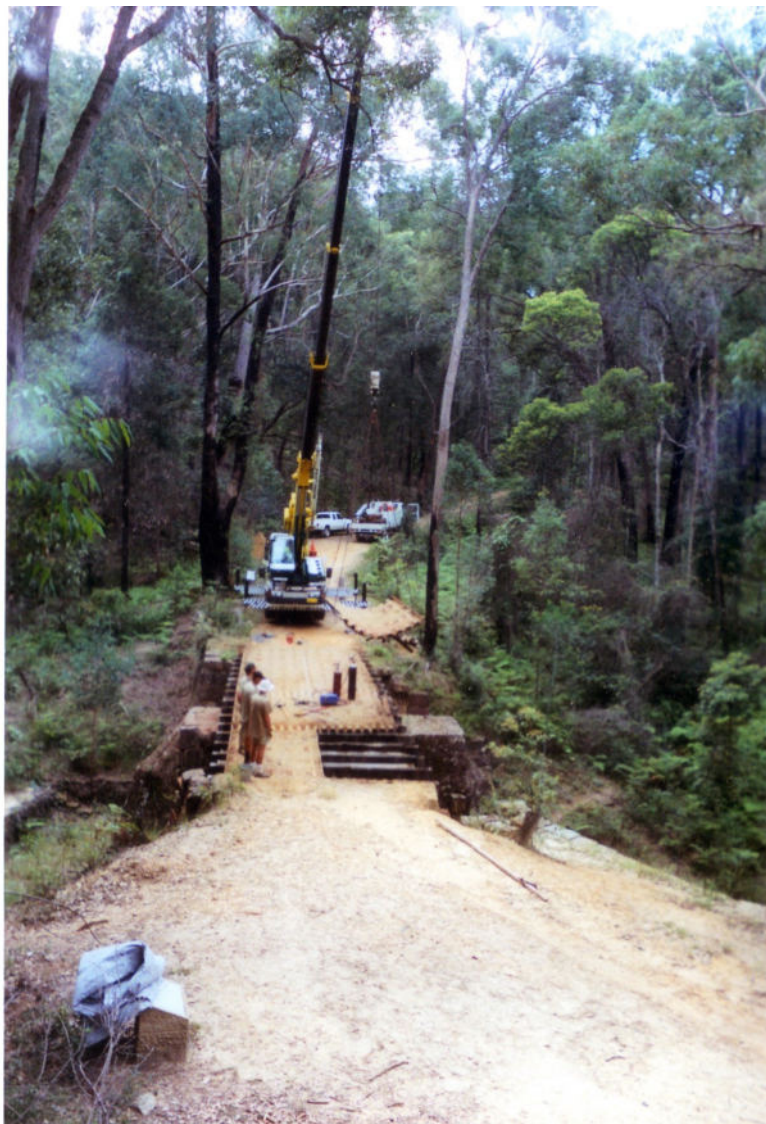
*[Demolition of Clares Bridge decking - lifting off the first sheet of metal decking.]*

To remove the bridge decking, a large extendable mobile crane had to come in via Dubbo Gully with removal of, and then replacement of, the berms on the steep rises on that fire trail. Once removed, all the decking went out that way. With the decking removed more work was revealed. Back from the stones was the concrete block. It had been poured into an open bottom form work and had flowed through the open fill towards the stone wall. Before the wall could be dismantled the concrete block had to be removed, this would involve cutting it into pieces and before this could happen the area had to be prepared.

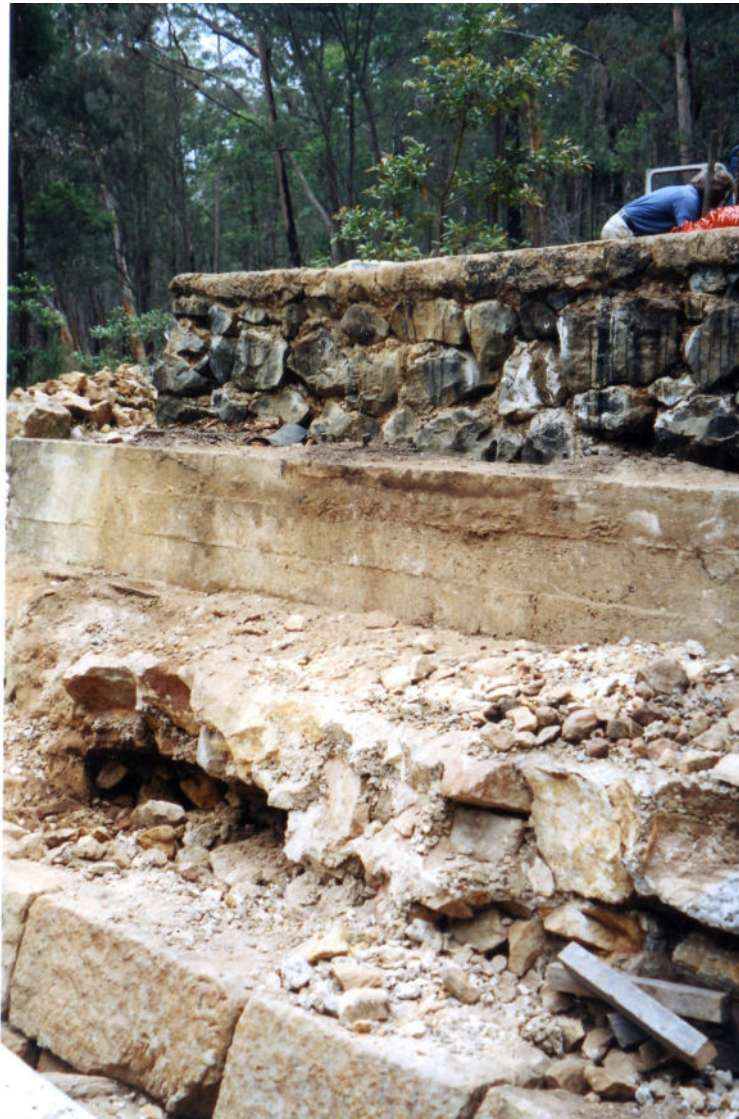
*[Ramp onto the bridge deck on concrete that carried the deck's stone abutment.]*

Behind the concrete block was a blue metal and concrete wall about 30cm to 40cm high that had formed a ramp to get the road onto the 1960s decking. Getting rid of the blue-metal involved someone with a bobcat digger and tip truck. With the blue metal gone we still had to dig out the soil under the blue metal to the base of the concrete so the concrete could be cut. Out went another request to the Metropolitan weekend detainees. Before any of this could happen, the scaffolding had to be in place around the props as the first job was extract the top row of stones from the concrete that had flowed up to them. This was very difficult work. Just before the scaffolding was installation most of the washed in road base was remove by hand. With everything organised, the concrete cutter was organised and I waited for them at the Western Commissioners Track entrance. In 2004 mobile phone coverage was very hit and miss along the river and I waited and waited.

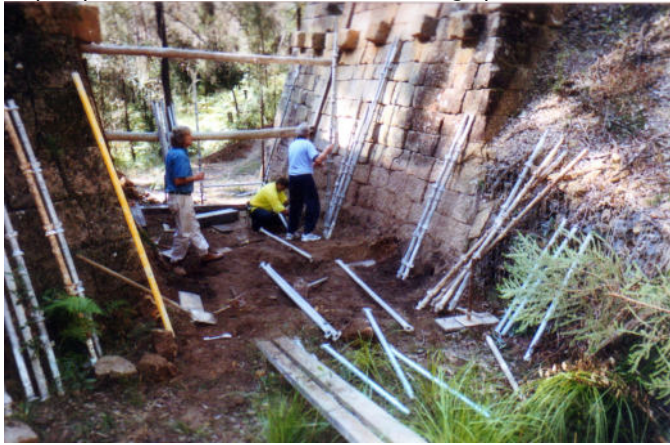
*Installing the scaffolding*

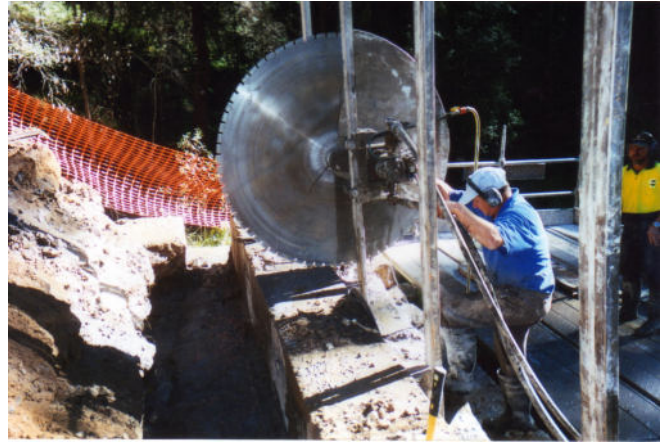
*Concrete cutting saw at work.*

Finally they arrived. They had got lost by taking the wrong ferry. Setting up the saw was quite a process; as the stone cutter also had to bring a water tanker to supply water to keep the saw cool. They were to cut the block into pieces small enough to be lifted out by the stonemason's crane. This was the first job to be done when the stonemason returned. But the cut up concrete blocks were too heavy to go out over the bridge at Ten Mile Hollow.

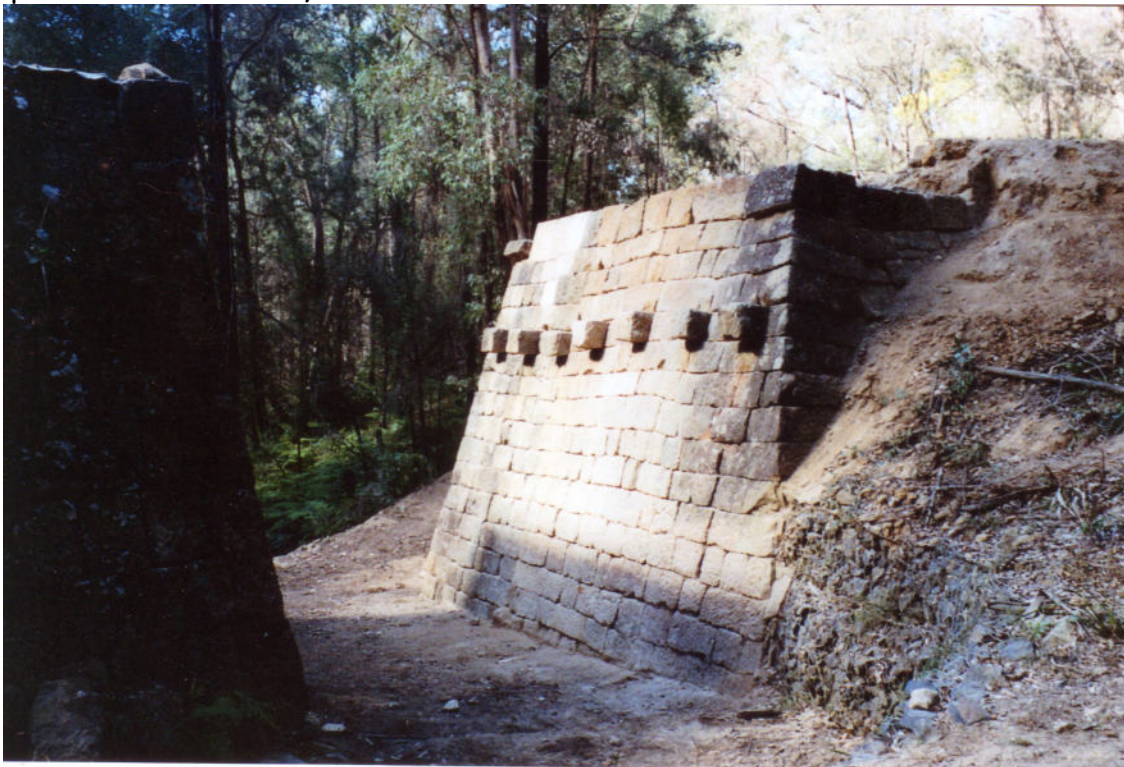
*The southern abutment of Clares Bridge restored.*

Each stone was lifted out and back again with a soft sling and cleaned with a nylon brush before being numbered on top. Although not proven at the time, the stones were re-laid on a small bed of dry stone dust. As we deconstructed the wall each stone was sitting on a small layer of 'dirt' that had to be brushed off before numbering. A number of years later it was discovered in deconstructing a section of Ramsays Leap that the convicts did lay the stones with a layer of stone dust and this was what we were seeing as dirt.

As the wall was being taken down, it was found there were a number of additional stones that, although appearing sound on the external surface, were too badly cracked or crushed to be reinstated. With the wall deconstructed, the stonemason Ken Fletcher (then living at Wollombi) and his crew took a home break, while he sourced and cut replacement blocks. One block, one of the corbels, went off site to be repaired. Another stone was pinned on site after I having obtained slacked lime and pozzolan powder and a long stainless steel rod to use as a pin. With everything in place, the stonemasons returned and the reconstruction commenced. As the wall went up again so did the scaffolding. As we neared the top in one row there was an approximately a 8cm gap between our work and the previous

reconstruction so one of the unusable stones left from the previous reconstruction was repurposed and cut to fit the gap.

As per the Burra Charter, all new material was identifiable and dated. When we were finishing there was a gap between the top of our work and that organized by the NPWS so Ken cut three stone to fit and was going to put his and his crews names on them. I turned round to find he had added Elizabeth as well.
