Convict Trail Project

May 2024 Newsletter

Work at Thomas James Bridge.

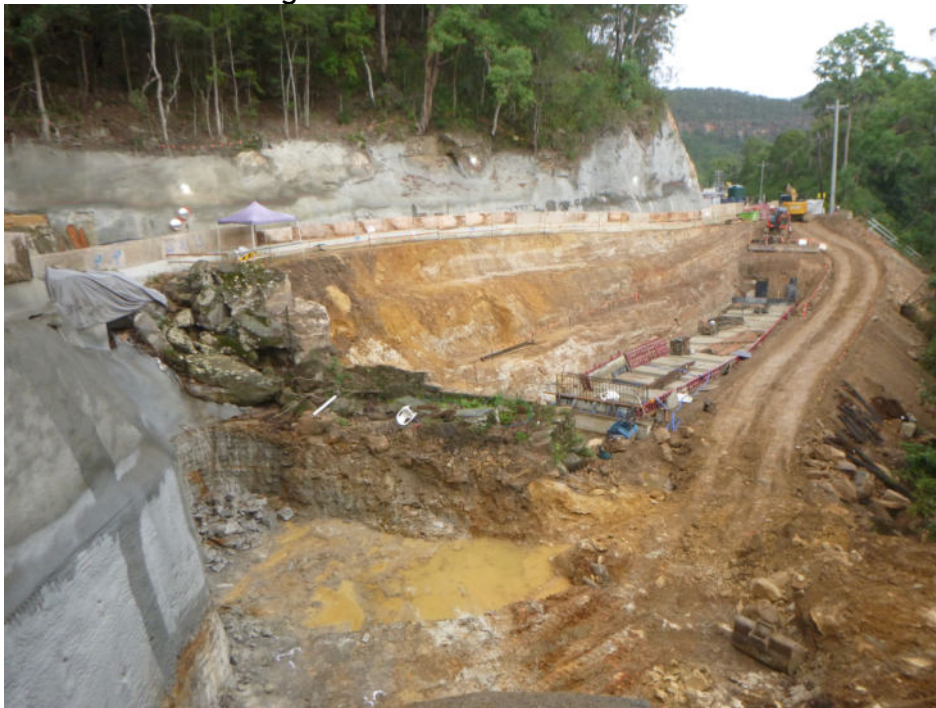
This photo taken 20 April 2024 from the top of excavation the Devines Hill end looking back towards the ferry, the side road is built up where the wall collapsed and runs below where the creek that flowed under Thomas James Bridge would have drained. The white plastic chair is sitting on the creek bed under Thomas James Bridge, with the base

stones on the Ferry side still in place. And one stone on the Devines Hill side still there under the white pipe. The temporary road runs against the cliff face behind the plywood fence behind the purple roofed shelter pavilion. The base concrete has been poured to support the road on the ferry side and the hole dug into grey shale ready for concrete on the Devines Hill side.

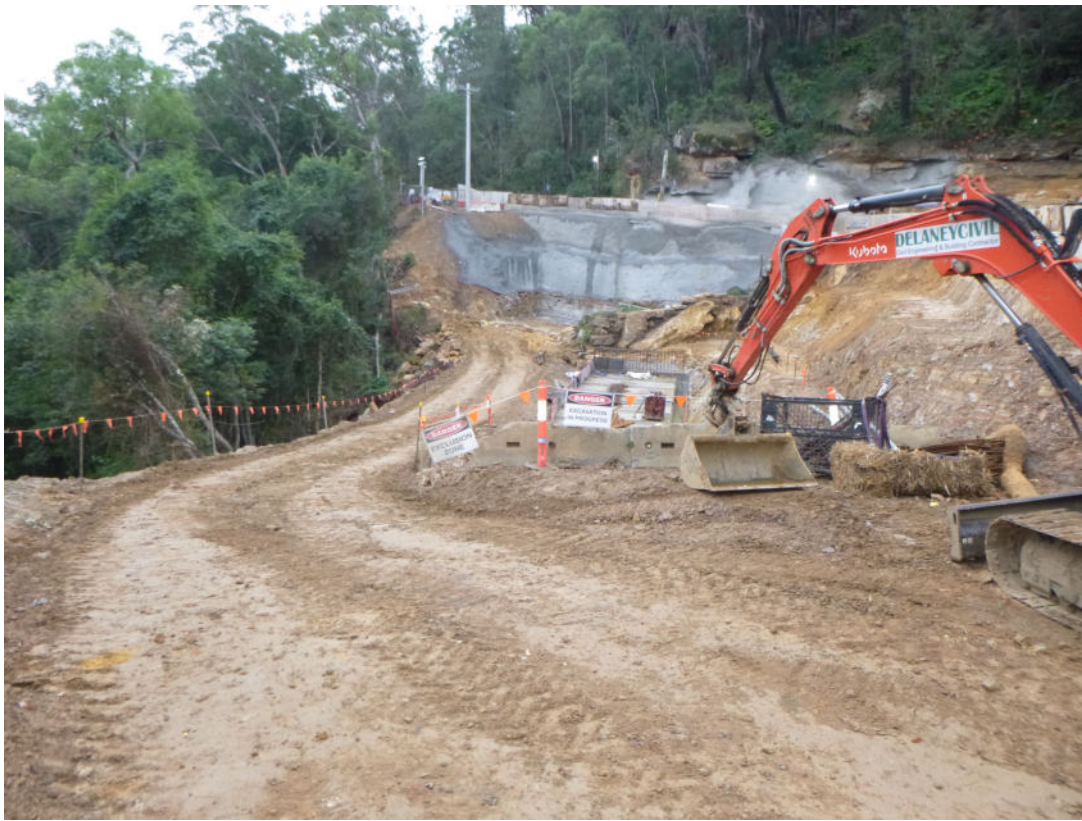
This photo taken 20 April 2024 at the Ferry end of the Thomas James road works looking over the excavation on that side towards Devines hill. Shotcrete in centre of picture is on the excavation on the Devines hill side of TJ bridge.

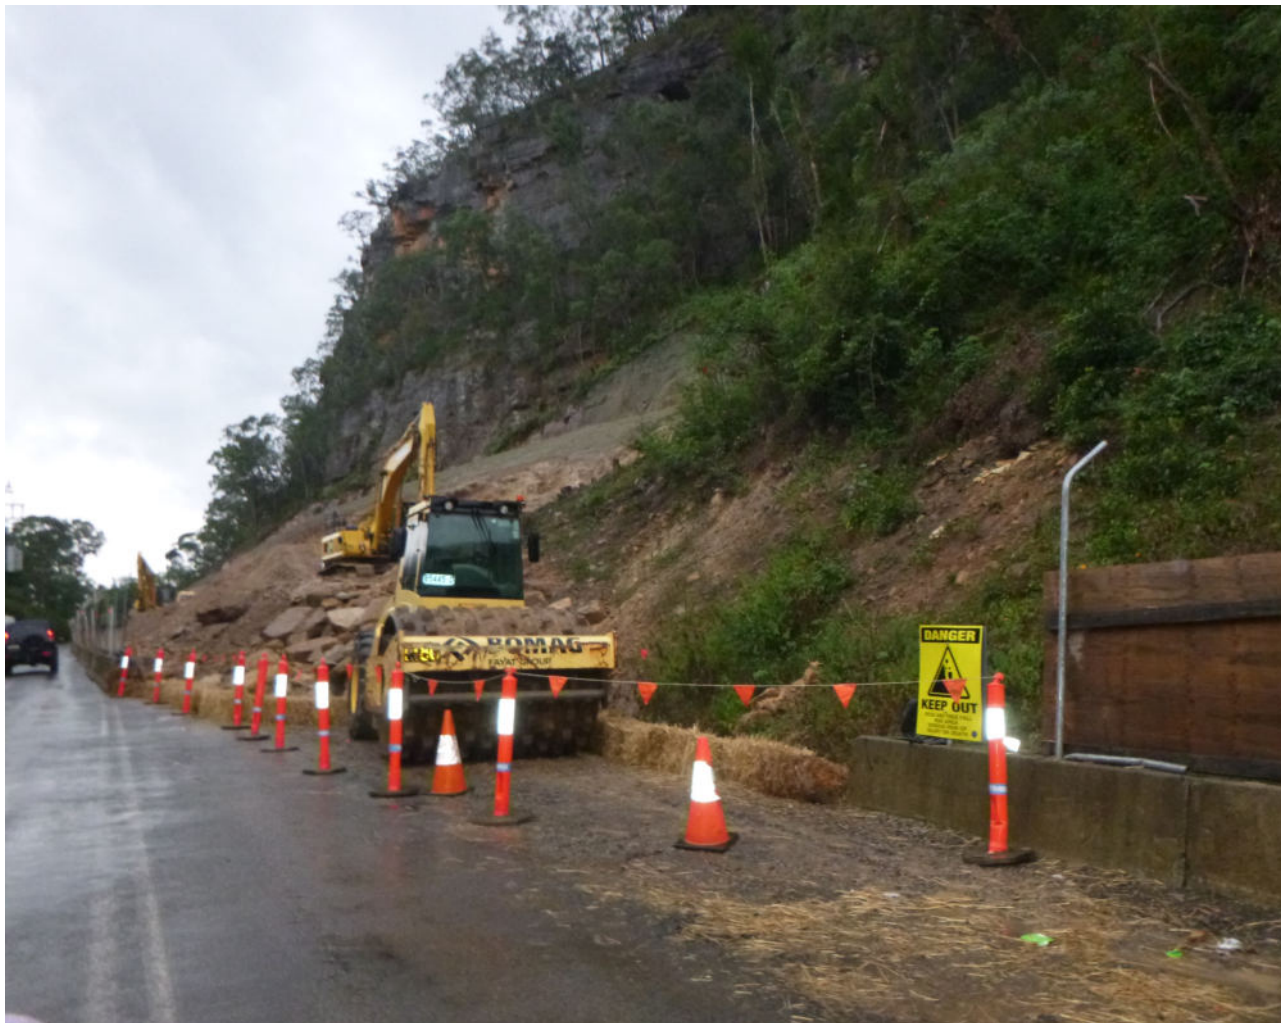
Photo taken 4 May 2024 from just above the Ferry heading towards the TJ Bridge showing work on the removal of the rock fall.

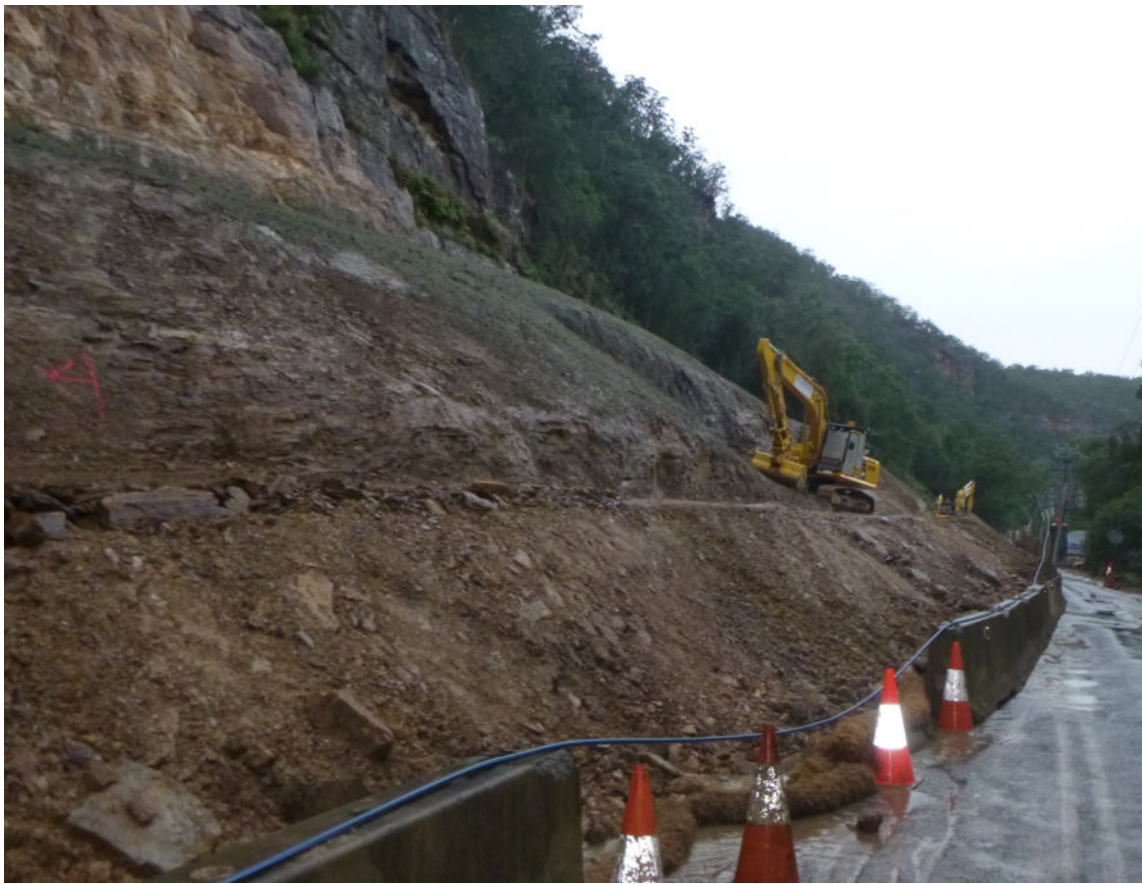
Photo taken 4 May 2024 from closer towards TJ Bridge looking back towards the Ferry over the area of the rock fall removal and stabilization.

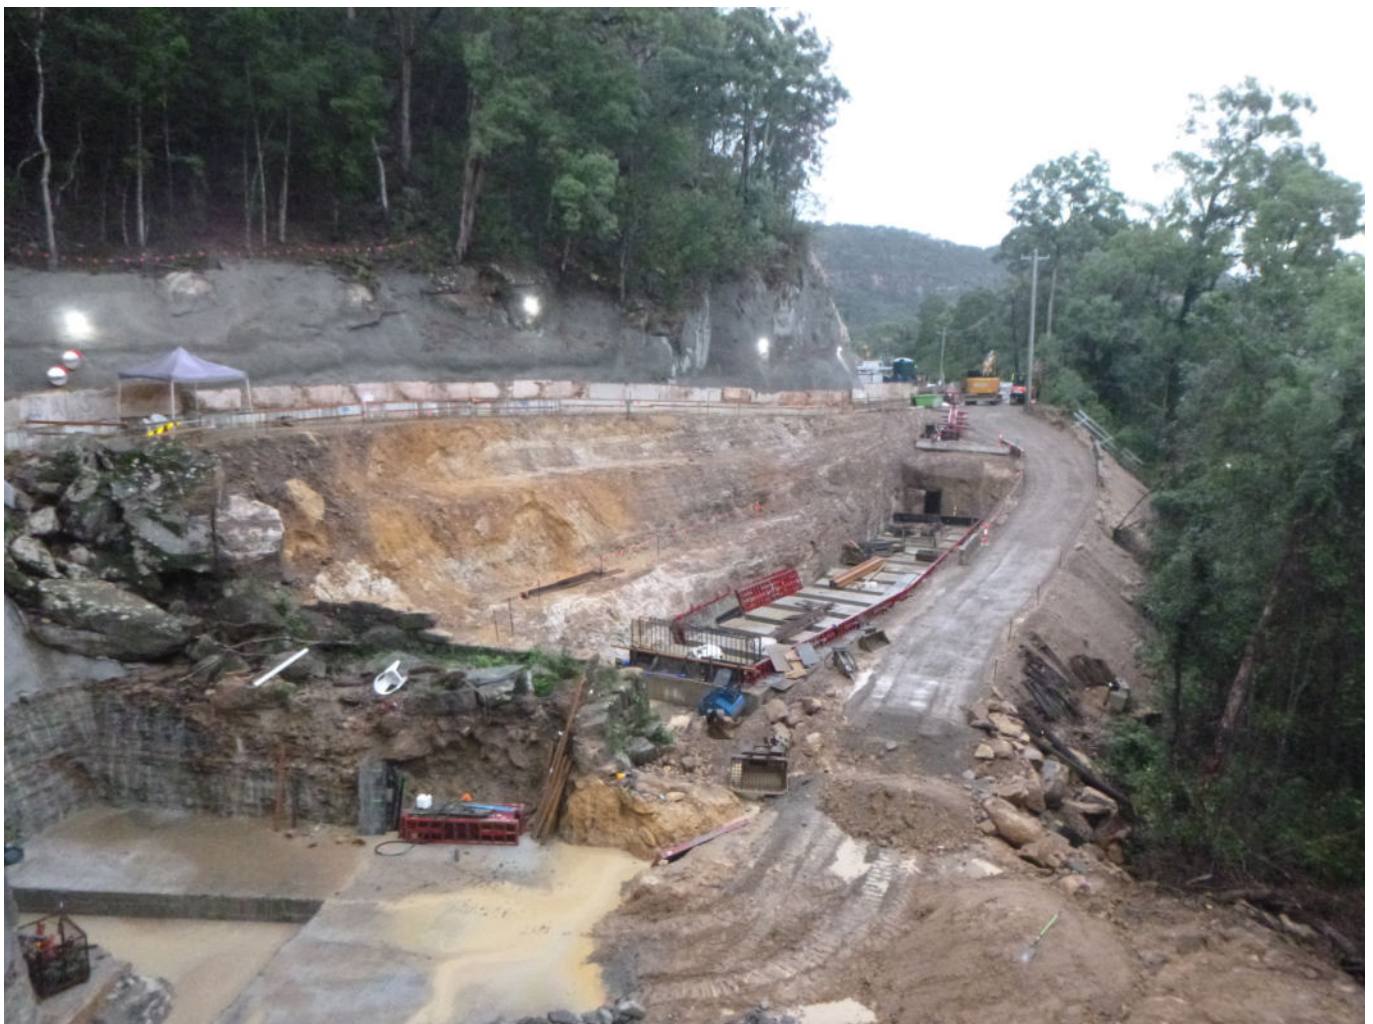
Photo taken from same position as photo taken on 20 April showing the progression in the works despite the wet weather. Concrete base poured on Devines Hill side of bridge base.
